Functionality Assessment of Household Tap Connection under National Jal Jeevan Mission - 2022

Har Ghar Jal
Jal Jeevan Mission

District Report: Tawang, Arunachal Pradesh
Survey Duration: March to April 2022

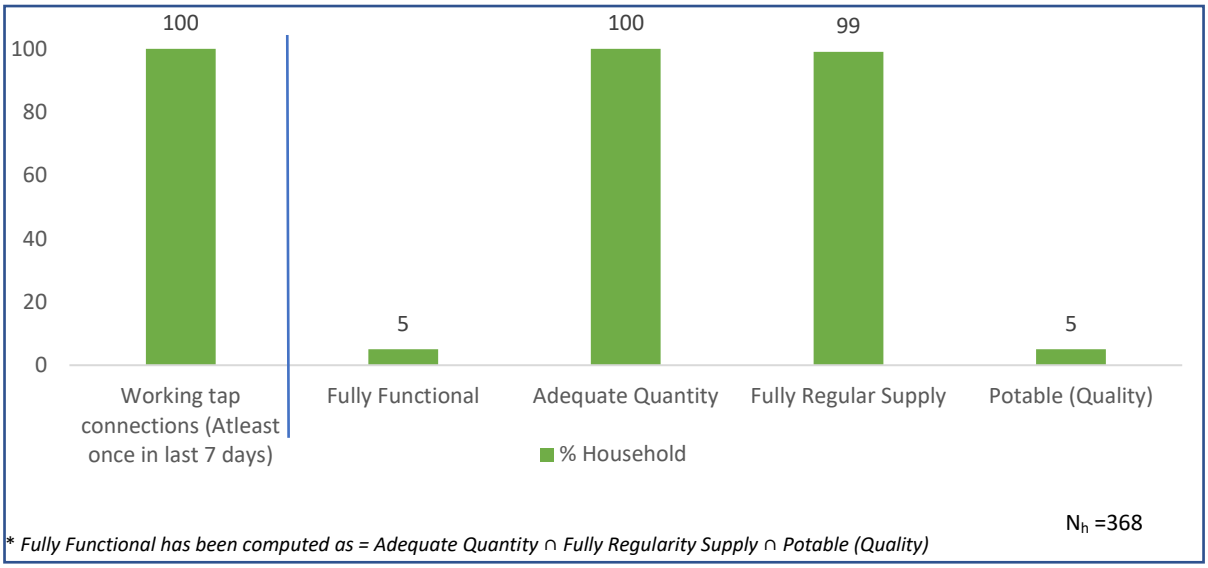
Figure 10: Functionality of HH tap connection

It has been found that 100 percent of the sampled HHs (N=368) had working tap connections (i.e., received water at least once in last 7 days). More than five out of ten (5 percent) HHs had fully functional tap connection (i.e., HHs receiving adequate quantity of prescribed quality of water on a regular basis).

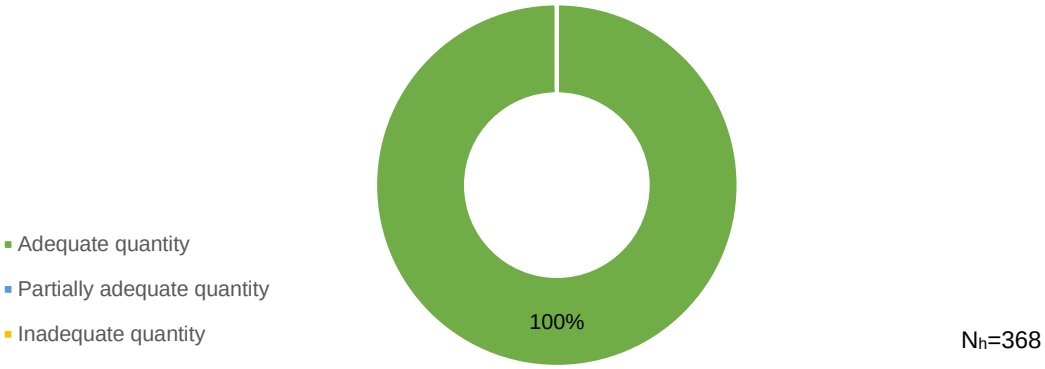
Figure 11: Quantity of water received by households

100% HHs reported receiving adequate quantity of water

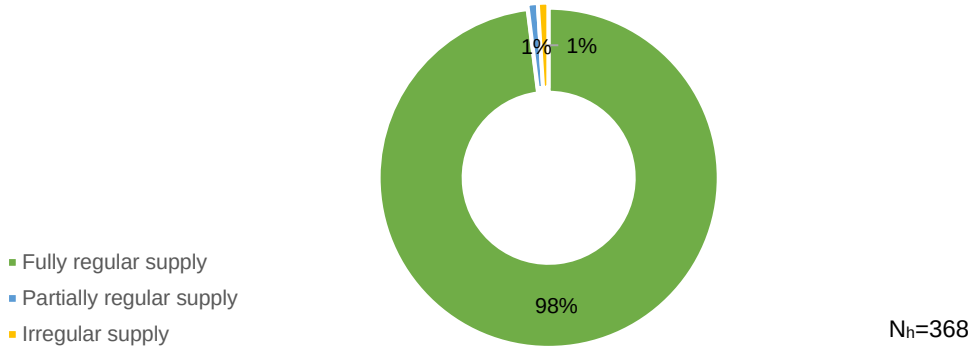
Figure: Regularity of water received by households

99% HHs receive a regular supply of water (as per agreed schedule)

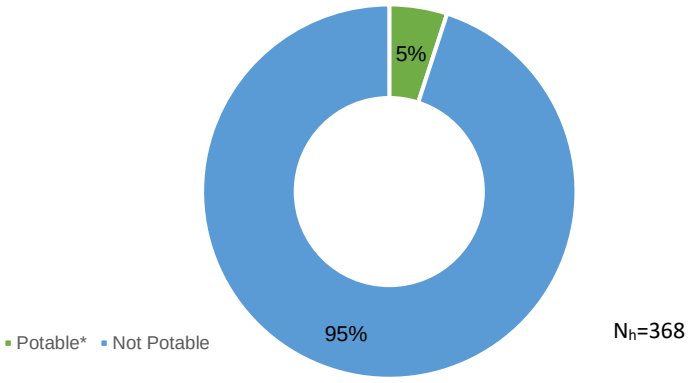
Figure 14: Potable water received by households

**Potable water has been considered basis testing of water samples through laboratory tests for physical, chemical, and bacteriological as given in Table 4 parameters (within acceptable/ permissible range) and onsite testing of pH. The details of laboratory test are mentioned in the table given above in the glossary.*

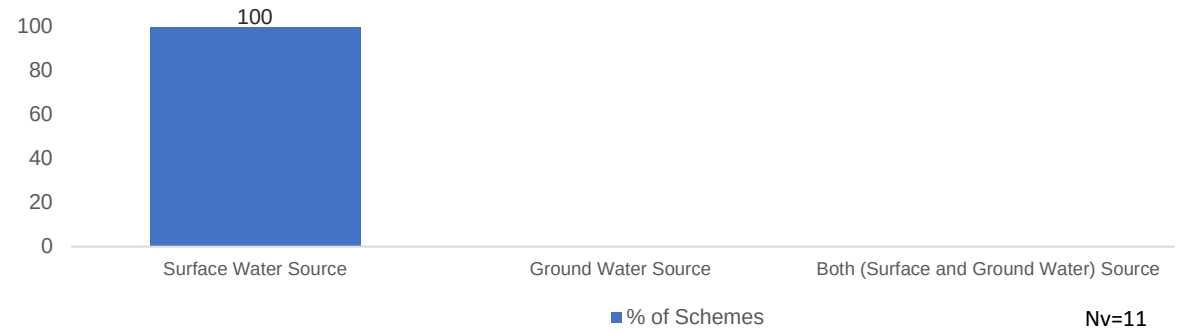
Figure 19: Schemes based on water source in village

100% of schemes are reported to be based on surface water.
